Memorandum

Project# 270030.003

RE: McLoughlin Investments Strategy - Technical Memorandum #3 Corridor Background and Needs

CORRIDOR BACKGROUND AND NEEDS

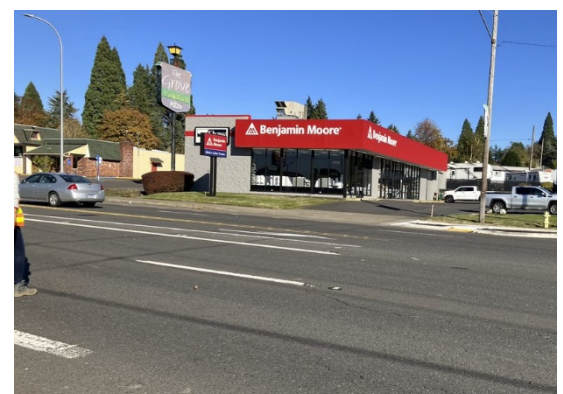
There are multiple existing mid-block and intersection crossing locations along the corridor with a center refuge median but no signing, striping, or enhancements highlighting the pedestrian crossing. Additionally, there are existing crossings without a center refuge median provided. During the RSA field visits, the team observed vehicles failing to yield to pedestrians waiting to cross and noted that crossing was overall uncomfortable at these unenhanced locations. It is noted that pedestrian and bicycle crashes recorded in the crash data also involved people crossing at non-enhanced crossing locations. It was discussed that even at existing crossings with rectangular rapid-flashing beacons (RRFBs), some team members felt uncomfortable while crossing because it was hard to tell if approaching vehicles were going to stop. There are various locations along the corridor with recently installed Americans with Disability Act (ADA) ramps but no marked crosswalk or refuge median. Finally, there are segments along the corridor with significant distance between existing enhanced crossings where there is need for new enhanced crossings to provide comfortable

Figure 13. Existing crossing without a center median or other enhanced treatments

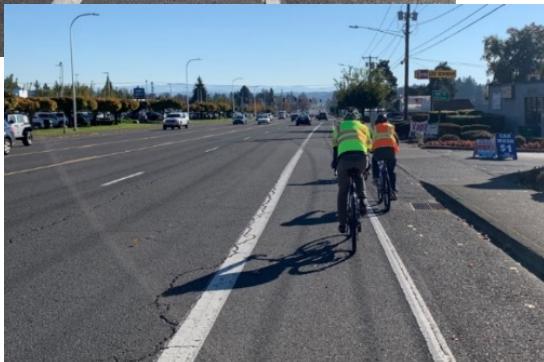
Bicycle Lanes

During the RSA field visit, a key observation was that biking along the corridor felt overall uncomfortable due to the narrow bicycle lanes with no physical vertical separation from the high speed and volumes traffic. They also noted poor pavement conditions, a lack of maintenance within the existing bicycle lanes, as there was quite a bit of glass and other debris within the bicycle lane, and undesirable grid inlets in the bicycle travel path. The team also noted that the bicycle lane striping is inconsistent throughout the corridor. In some locations there is no buffer, others there is a buffer between the bicycle lane and motor vehicle traffic, others there is a buffer between the bicycle lane and curb, and at most signalized intersections the bicycle lane becomes a shared lane with right turning traffic.

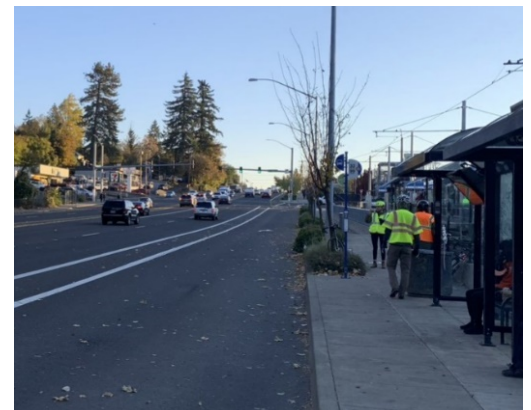
Figure 20. Bus stop located near the Park Avenue Max station

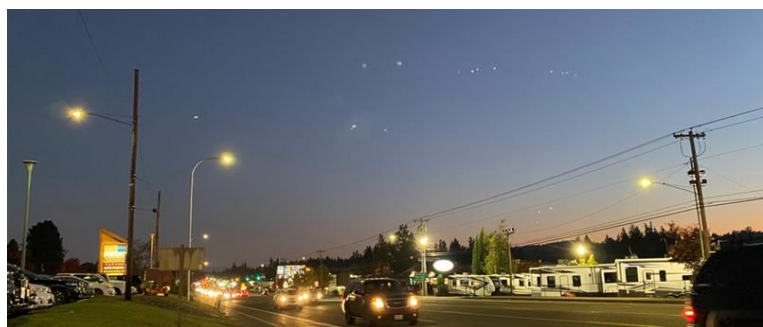
The team identified inadequate lighting at the southern end of the corridor, particularly along the Clackamas River Bridge. It is noted that Clackamas County has completed lighting infill along their segment of the corridor, however the segment within the City of Gladstone (MP 10.3, Glen Echo Avenue to MP 11.2, the Clackamas River Bridge) has inconsistent lighting. Additionally, the team noticed no lighting on the east side of McLoughlin Boulevard north of Park Avenue. Ambient lighting from businesses along the corridor was noted by those in the RSA as making it difficult for people driving to see people crossing the roadway. The RSA team also

Figure 21. Ambient lighting from nearby businesses conflicting with illumination along the corridor

observed that the existing street lighting at current RRFB locations does not always highlight the correct side of the pedestrian crossing, resulting in back lighting which results in a shadow being cast over the pedestrian making them less visible to oncoming drivers.

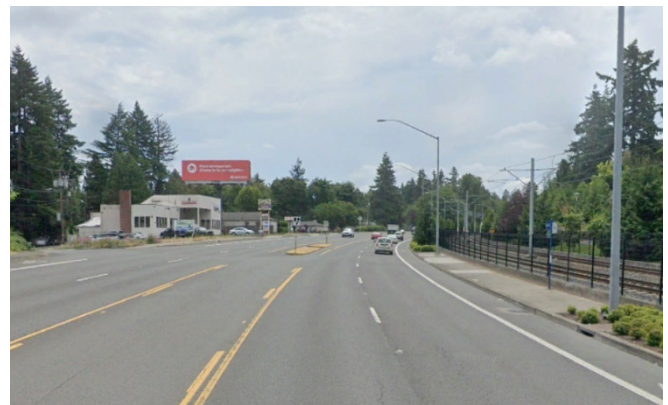
The team discussed the need for improvements at or consolidation of the existing transit stop at Lakewood Drive, located at the north end of the corridor. The existing bus stop (serving southbound trips) currently has no sidewalk connections or pedestrian crossing to support access to the transit stop.

Figure 22. Existing unenhanced crossing and sidewalk gap at the Lakewood Drive Transit Stop

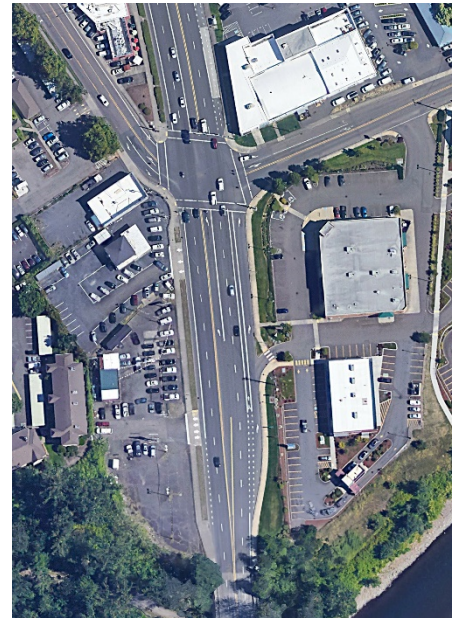
Figure 23. McLoughlin Boulevard/Arlington Street-River Road

The team identified several safety issues at the intersection of Arlington Street and River Road with McLoughlin Boulevard. The RSA team observed northbound right turning vehicles travelling quickly through their turns due to the long deceleration lane and wide curb return radius. Many did not stop at the intersection before making a right turn on red. Additionally, eastbound right turning vehicles were also making fast turns and would often not stop before they turned, even when the signal was red. The skewed geometry of the intersection creates a wider eastbound to southbound curb return radius.

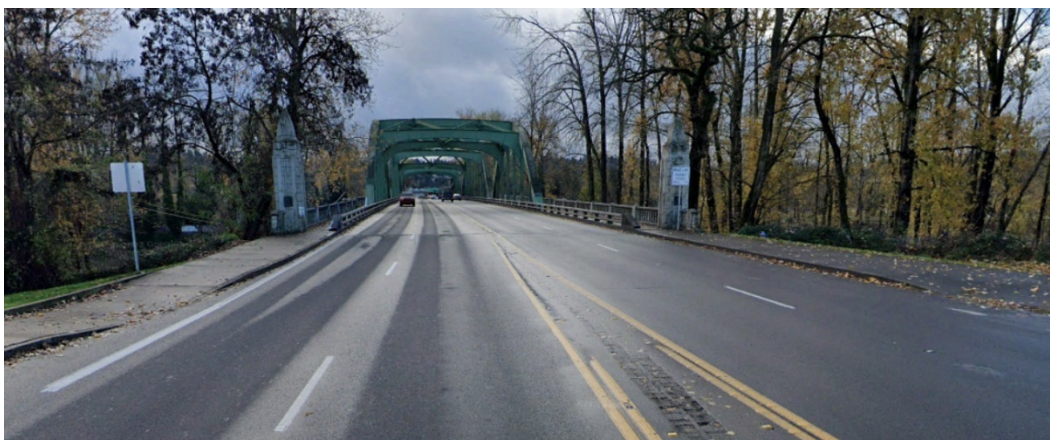
Figure 24. Clackamas River Bridge (facing South)

The team identified multiple safety issues around the Clackamas River Bridge and the McLoughlin Boulevard signalized intersection with Arlington Street and River Road at the southern end of the study corridor. One issue is the existing sidewalk on the bridge is very narrow, potentially narrower than 3.5 feet in pinch point locations. There are no bicycle lanes on the bridge, forcing bicycles to use the sidewalk or share the travel lanes. Most bicyclists were observed biking on the bridge sidewalks, indicating that it is more comfortable to ride on the narrow, shared sidewalks than in the travel lane. It was also noted that the bridge does not have any lighting and was therefore very dark at night, and the team noticed that some vehicles seemed to be traveling faster than the 40mph speed limit over the bridge.

A major conflict location was identified on the north side of the bridge between people driving and biking. For bicyclists traveling northbound (using the shared pedestrian/bicycle sidewalk on the east side of the bridge), there is an existing bicycle ramp down from the sidewalk that conflicts with the start of the existing northbound right turn lane entrance (taper) that serves local development and Arlington Road.

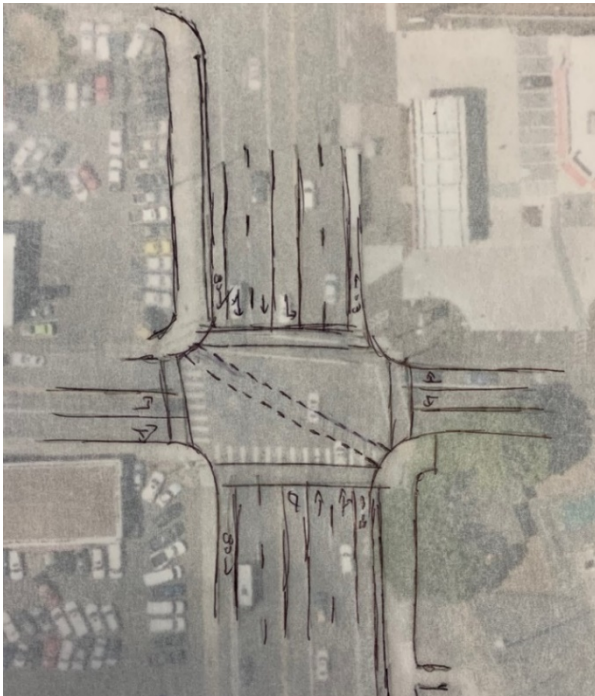
**Figure 26. Alternative 1:
Diagonal Bicycle Signal**

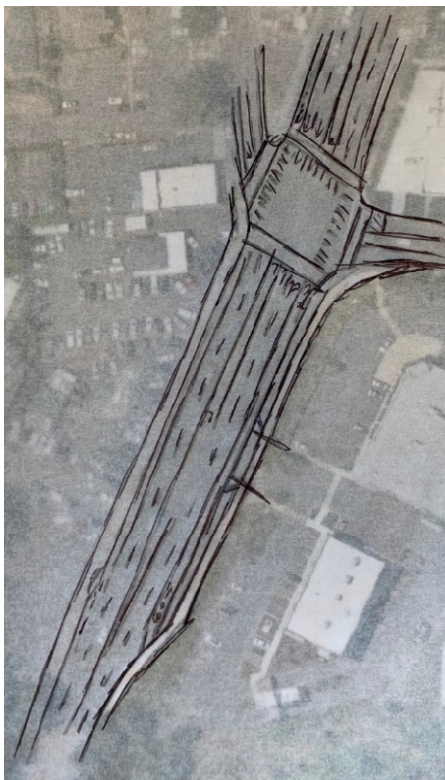
Figure 29. Alternative 1: Remove Exclusive Right Turn Lane

- Tighten curb return radii in the southeast corner of the intersection, potentially through the addition of a truck apron if needed to support truck turning movements
- Tighten curb return radii in the southwest corner
- Consider no right turn on red along the eastbound approach or install a "Turning Vehicles Yield to Pedestrians" sign
- Improve visibility for all crosswalk legs through improved intersection lighting

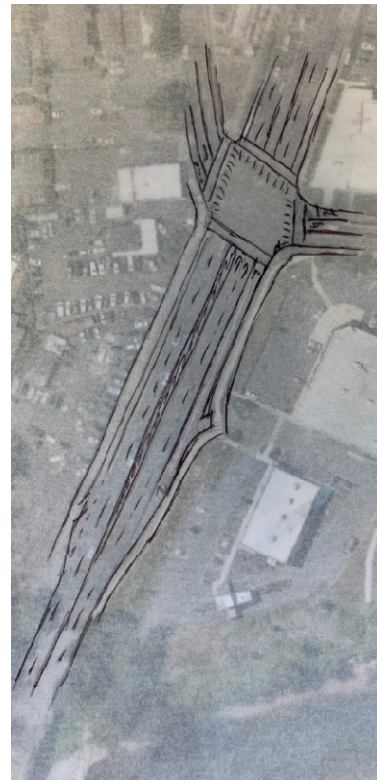
Figure 30. Alternative 2: Formalize Sidewalk Route for People Biking and Walking

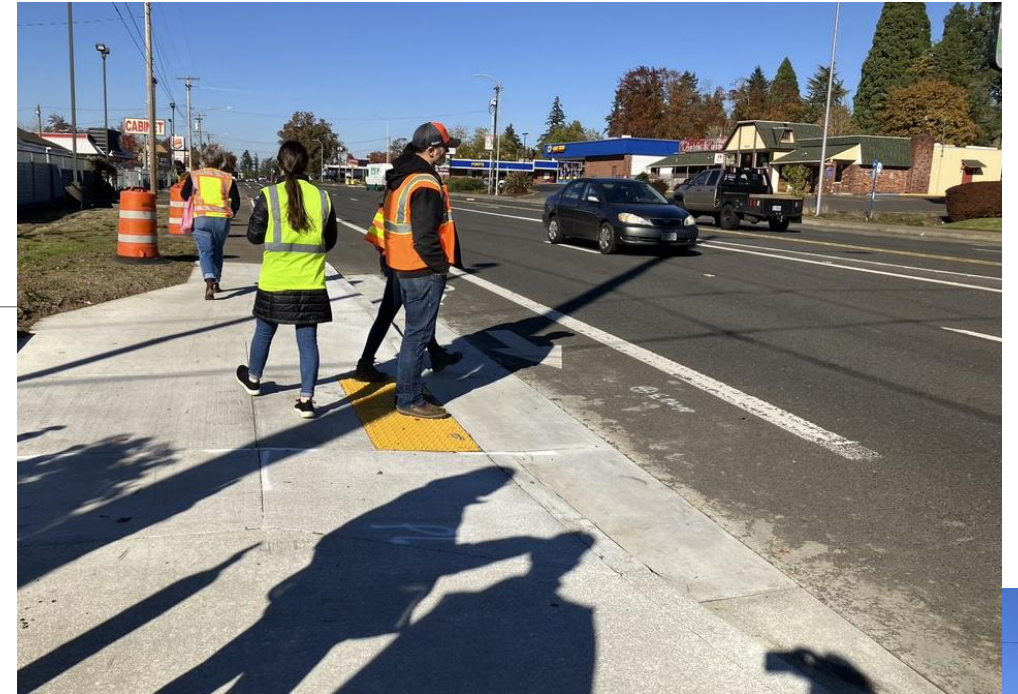
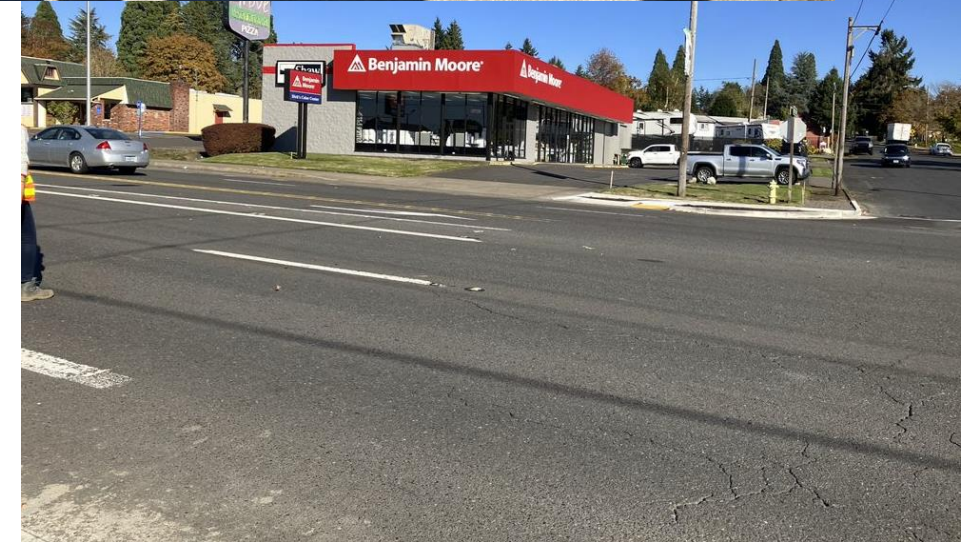
Pedestrian Crossings

- Multiple crossings with center refuge median, but no additional signing or striping
- Locations with new ADA ramps, but no marked crossing or median
- Segments with large distance between crossings
- Unsure if vehicles will stop at existing RRFBs

- Enhance existing crossings
 - Additional signing in median
 - Additional striping (ex: continental striping)
 - Provide median, signing, and striping at locations where there is currently no crossing
 - Enhanced treatments (RRFB, PHB, Signal)
- Lighting placement before pedestrian crossings
- Wayfinding improved at Trolley Trail crossing, distance to transit, etc.

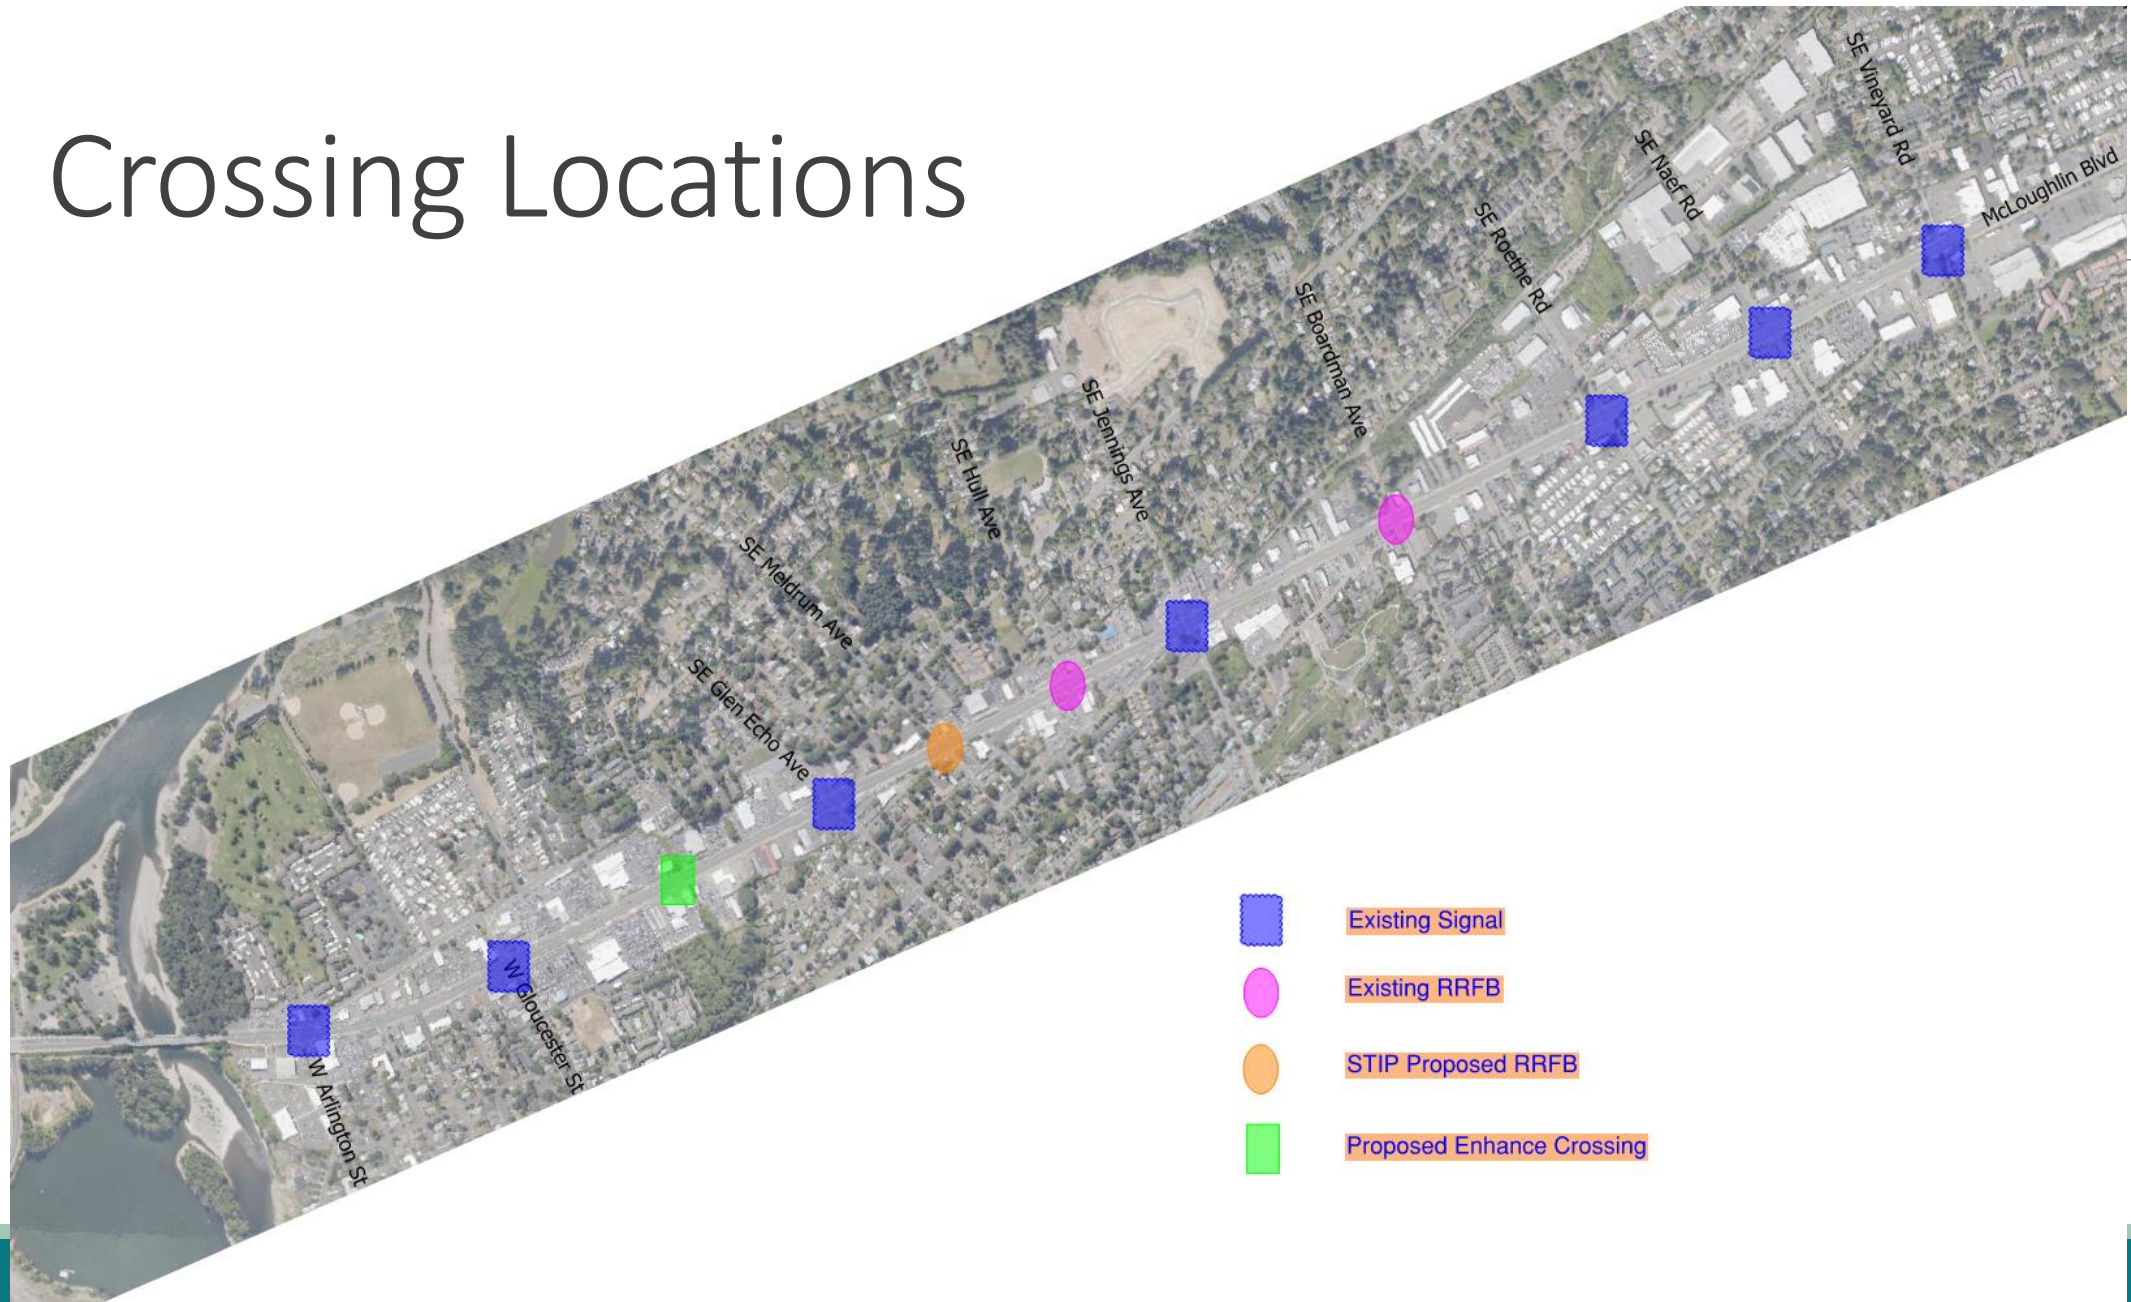
Crossing Locations

- Existing Signal
- Existing RRFB
- STIP Proposed RRFB
- Proposed Enhance Crossing

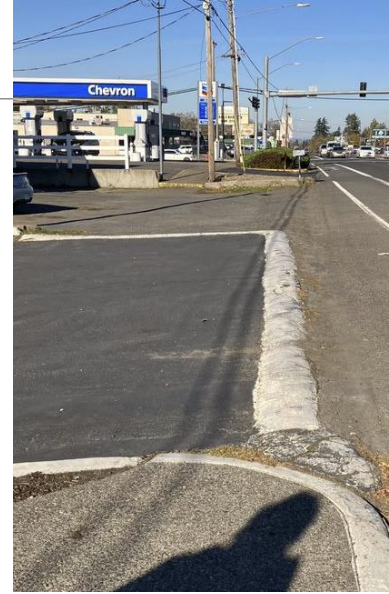
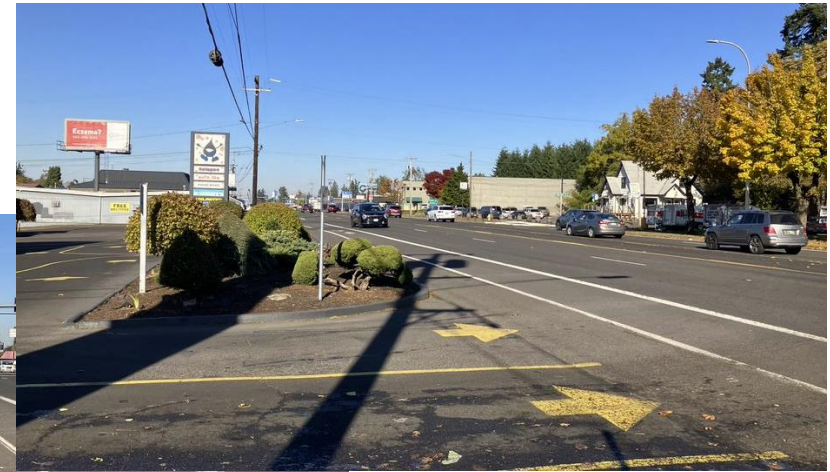
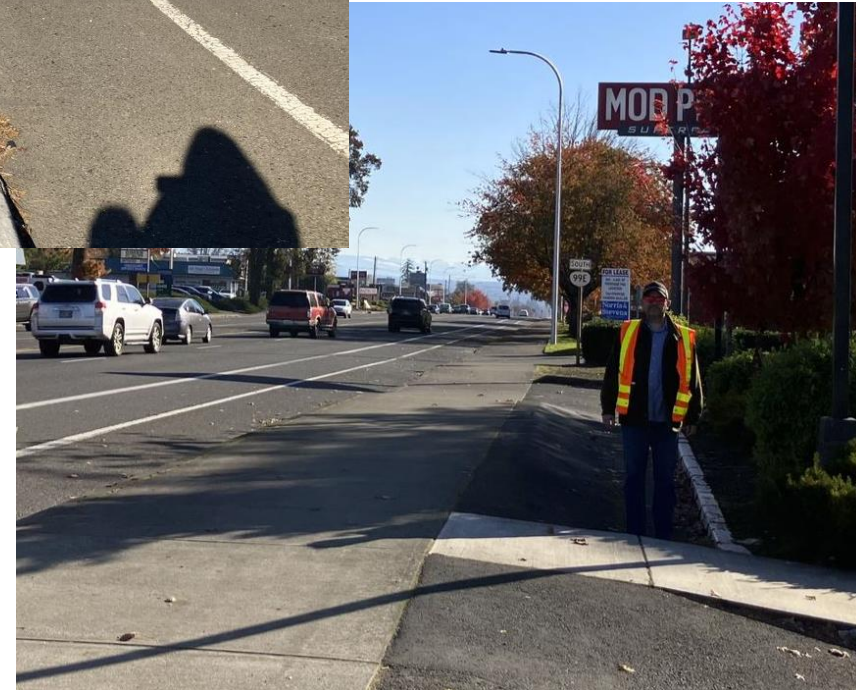
- Sidewalk gaps
- Narrow sidewalks
- ADA concerns
 - Non-ADA compliant ramps and driveways
 - Drop off/steep slope with no barrier along sidewalks (particularly on west)
- Wide “old-style” driveways
- Long wait times at signals and short crossing time
- Inadequate lighting
 - South section of corridor and Clackamas River Bridge

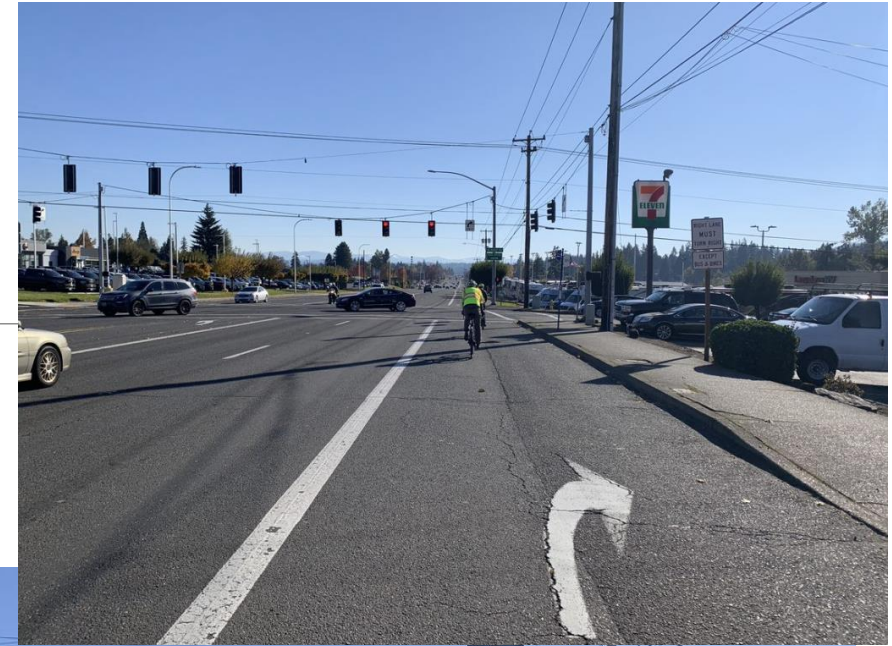
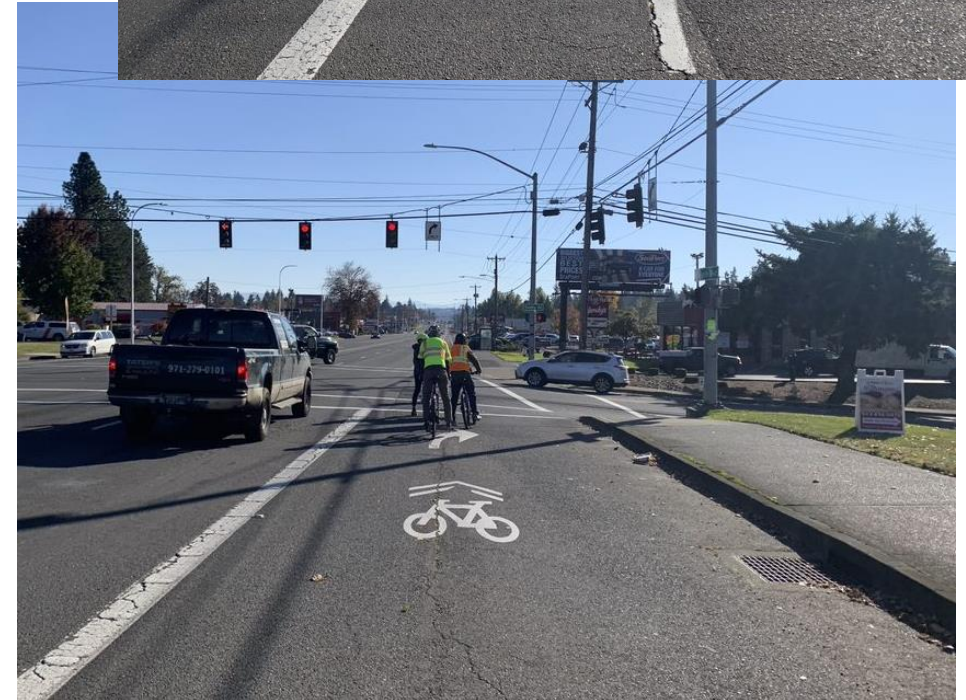
- Overall uncomfortable
 - Narrow and no buffer
 - Glass in bike lanes
 - Poor pavement condition
- Inconsistent striping
- Bike lane drops at intersections
 - Inconsistent signing/striping at intersections
- Trolley Trail Crossing
 - Challenging to cross/wayfinding

- Buffered bike lanes
 - Restripe area to include buffer between bikes and motor vehicle travel lanes
 - Buffer width will change based on additional space
 - Bike friendly rumble strip
 - Delineation where there is width
- Vertical separation (ex: tuff curbs)
- Remove existing right turn lanes
- Consistent signing & striping of bike lane drops at intersections (green striping/skip striping at intersections)
- Bike signal or additional wayfinding at Trolley Trail crossing (Jennings Ave)

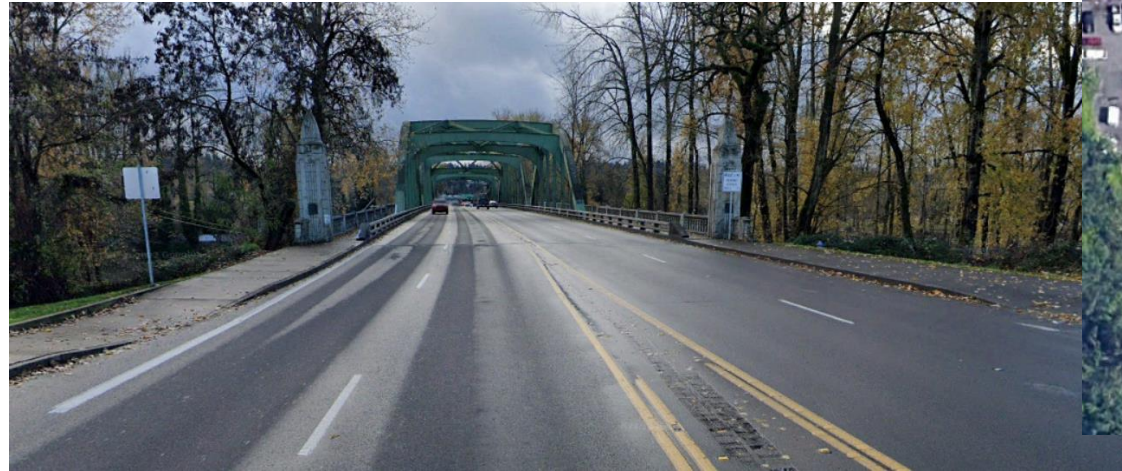
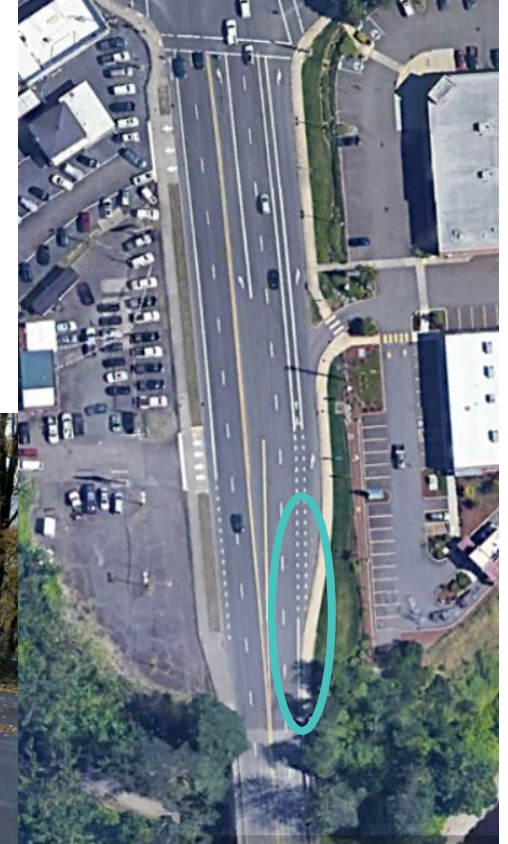
- Narrow shared ped/bike path, no bike lanes on bridge
- Conflict area with bike ramp down and long SBR turn lane and driveway lane
- High speeds on bridge
- Very dark at night

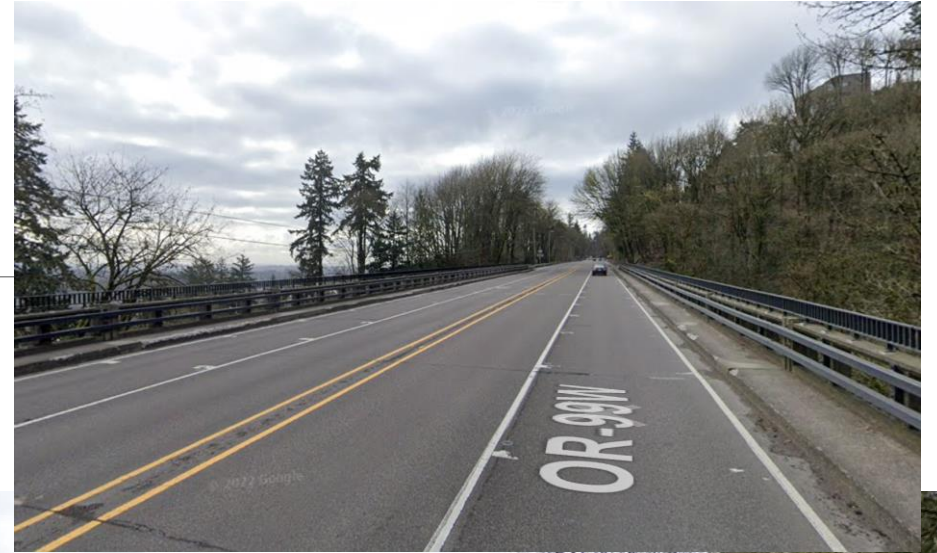
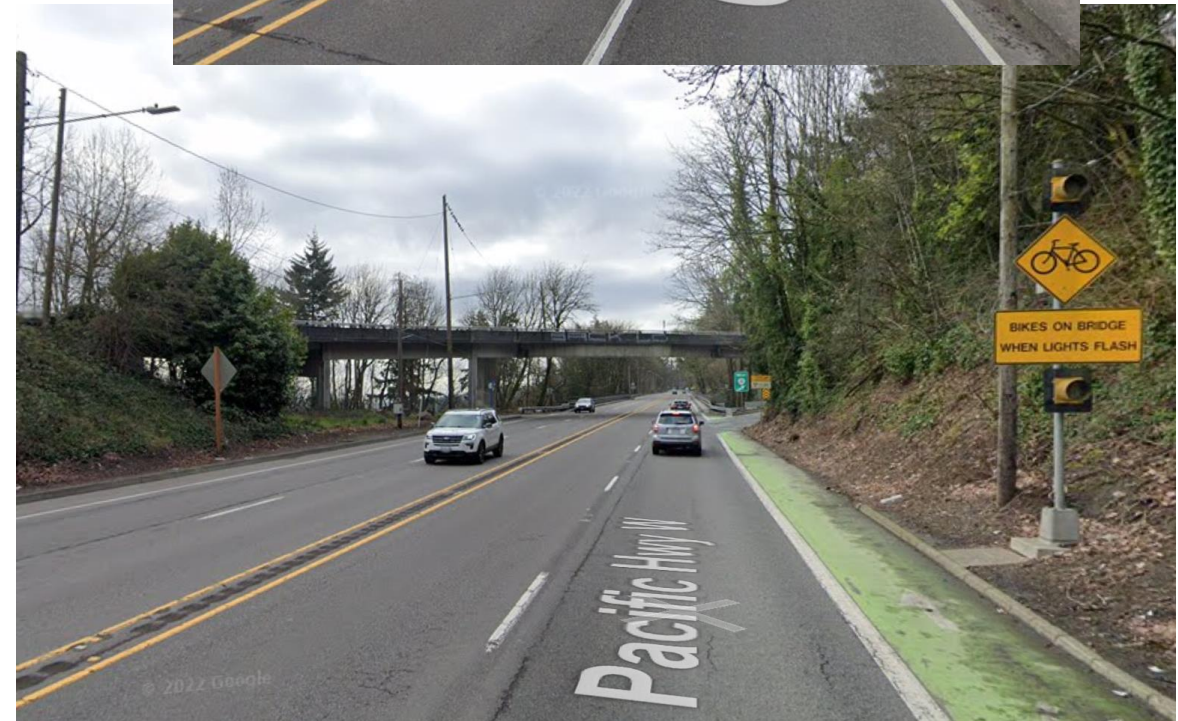
- Extra delineation for bike ramp onto bridge
- Actuated flashing “Bikes on Bridge” beacon
- Potential area for multiuse path from bridge to signal at Arlington
- Add lighting on bridge

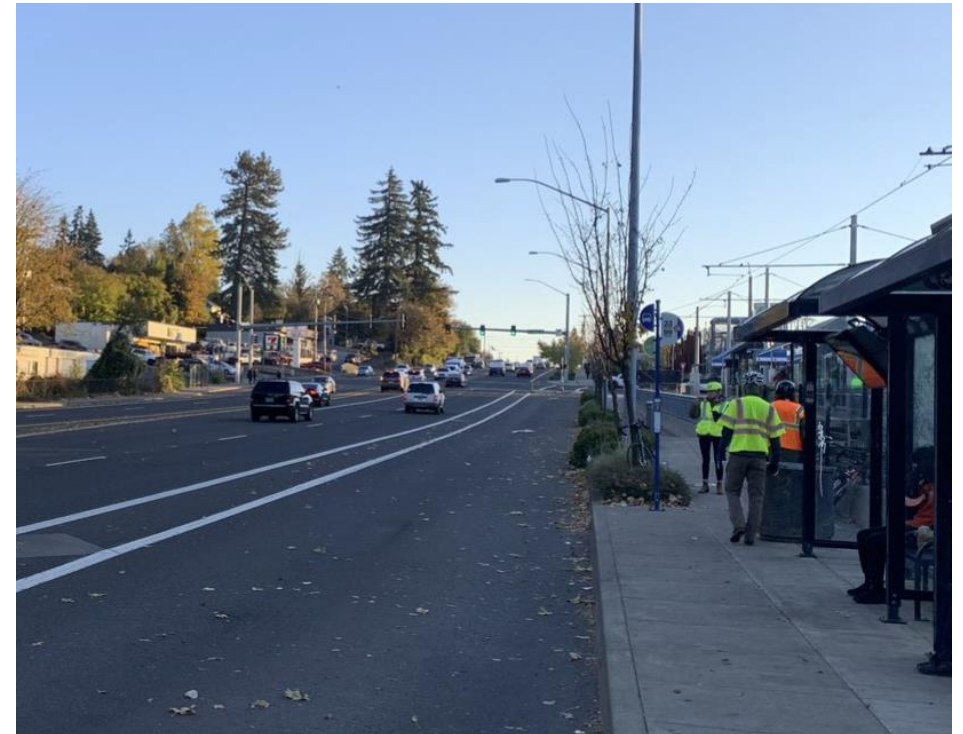
- Inconsistencies with pull out/in-lane bus stops and how this impacts bikes
- Park Avenue
 - People jump signal when they see their train/bus
 - High pedestrian crossing with long cross section
 - High speeds
- Observed many people waiting at bus stops (during all site visits)

- Bus stop north of Park Ave – improve crossing or consolidate bus stops
- ETC:
 - Consider queue jumps at Concord, Roethe, Courtney, & Oak Grove
 - Shared bus/bike or spot treatment to take additional space for a bike lane

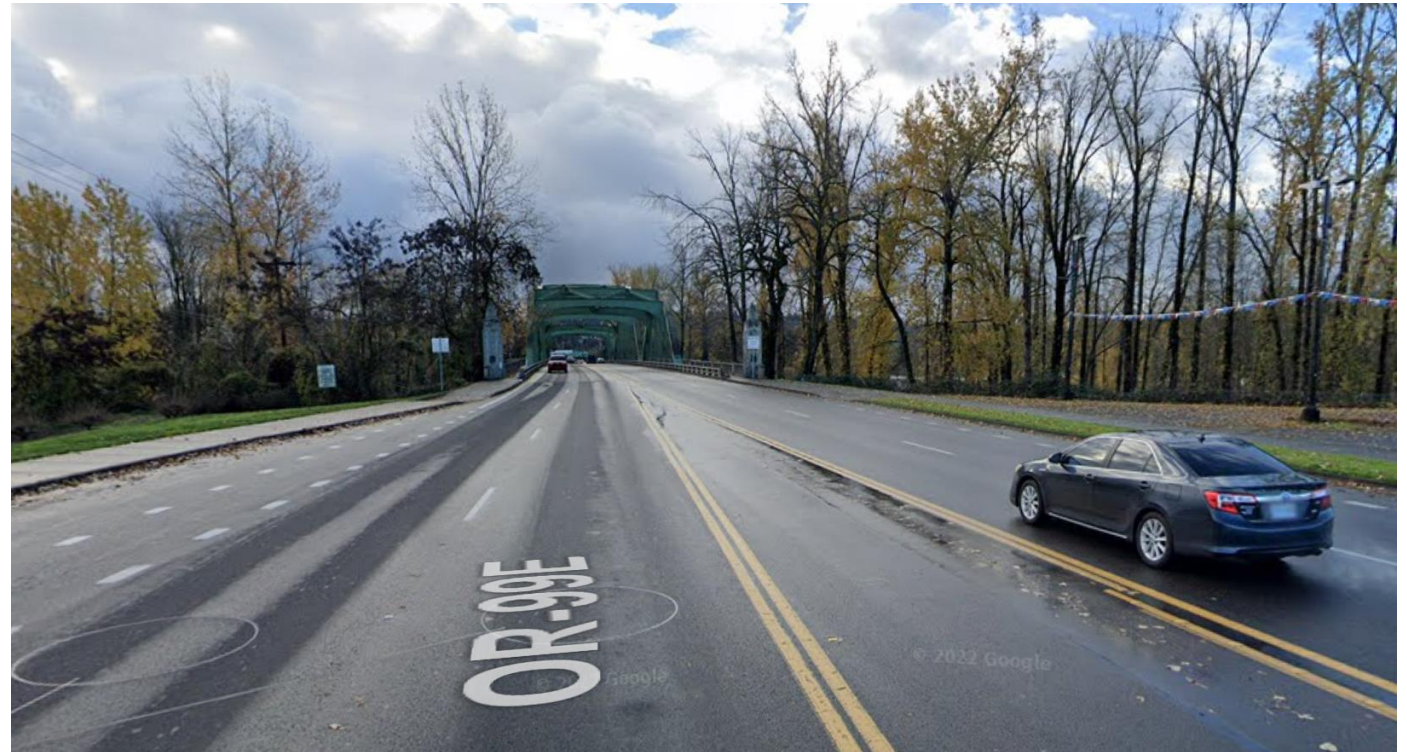
Speed

- Observed high speeds along bridge
- Overserved high speeds SB from Milwaukie as context changes
